WHITE PAPER

# SignalScout

Model 40

## Purpose

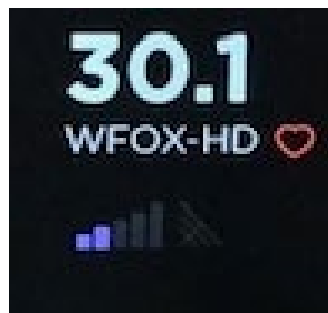
*Fox Channel 30 Signal*

In this White Paper, the SignalScout will test signal strength at various distances from the FOX Channel 30 tower in Jacksonville, Florida. The tower is a 1000 KW transmitter on RF Channel 32. The SignalScout will also be tested against a high accuracy Trilithic 860 DSP meter to verify measurement readings. The test will show that the lower cost SignalScout has the same and even better signal accuracy than the higher priced meter.

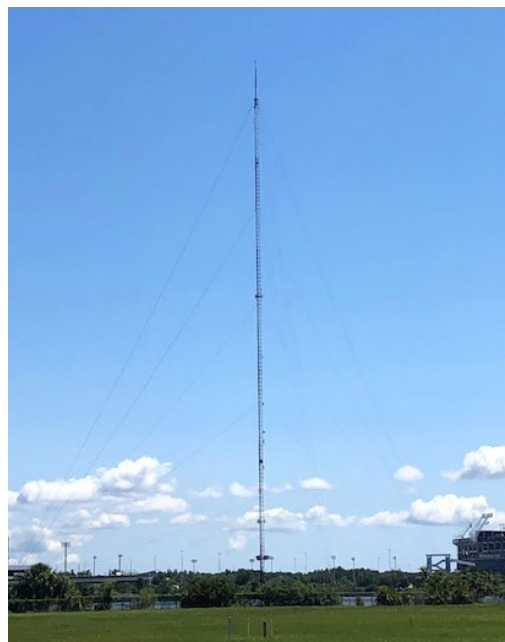
*FOX Ch 30 Transmitter*

The FOX Ch 30 tower in Jacksonville, Florida is one of the more difficult stations to receive in this community north of Jacksonville. The starting point will be approximately 50 miles from this antenna.

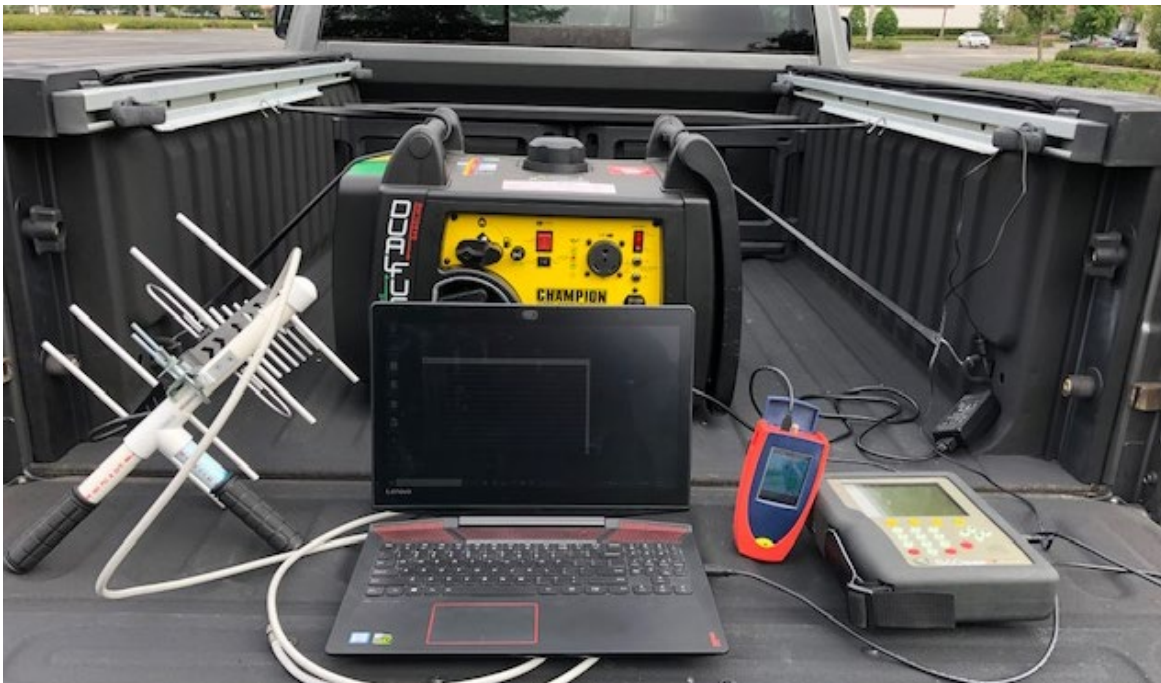
We loaded the truck with the following equipment and tested at distances of 50 miles, 40 miles, 25 miles, 15 miles, 10 miles, and 1 mile from the antenna above.

- Psiber Data Systems **SignalScout SS40** with V20.06.19 Firmware
- Trilithic 860 DSP. This is a QAM/ATSC meter that retailed for \$2000 and was one of the very first ATSC meters made that used a Broadcom 3510 Demodulation Receiver Chip
- Laptop for Data Logging
- 10 dB Gain Yagi antenna centered around 600 MHz and homemade handle kit
- Various cables
- Generator to power the 860 DSP meter

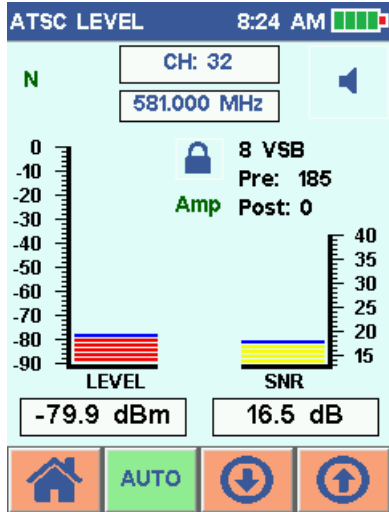
SignalScout Locked Screen

The Signal Scout locked on to the channel but was getting occasional Pre-Bit Errors as can be seen in the image below. This is consistent with a TV occasionally tiling on this channel. The 860 DSP with a 15-year-old receiver chip could not lock on at all at this distance.

*Note: MER on a digital channel is SNR. The Signal Scout auto-selected its pre-amp.*

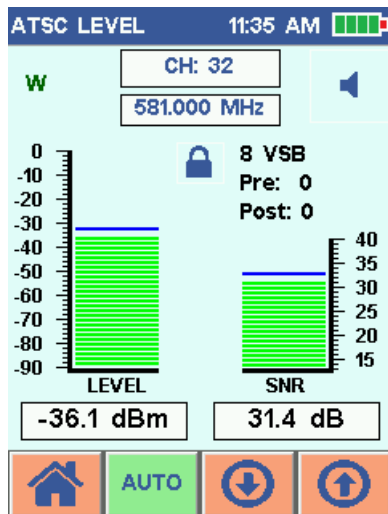
SignalScout Power Levels

The Signal Scout and 860 DSP are seeing a power level drop off probably because the majority of the antenna transmitter signal is pointed horizontal and away. This test was done looking up at the tower. The 860 DSP could no longer lock and its RF front end was probably overloaded at this point. They are both showing similar power readings
